Recoheat Airflow Heat Recovery Unit

EN 1856-2:2009 Testing

Recoheat Ltd

Report 102428/1

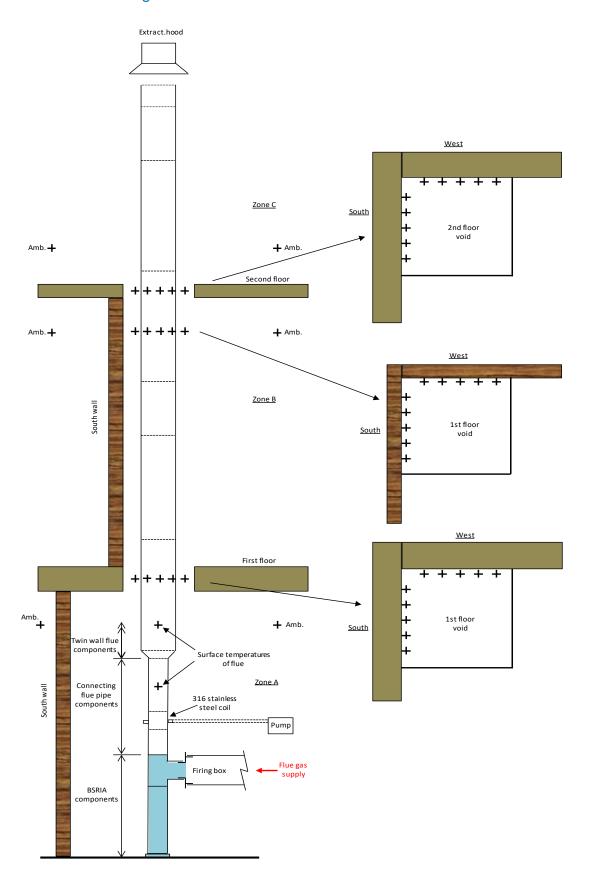
Installation drawing

The product was tested as a custom chimney installation incorporating connecting flue pipe components in Zone A provided by the client which includes the airflow heat recovery unit. These were connected to the firing tube using the BSRIA connecting flue pipe components.

The connecting flue pipe components were connected to a system chimney of the same diameter 450 mm below the ceiling in Zone A provided by the client.

The chimney then continues in a twin wall system chimney to the extract hood in Zone C. The twin wall system chimney was installed in corner/non-enclosed configuration in Zone B and Zone C.

The lower section incorporates the airflow heat recovery product plus connecting flue pipe components. The bottom sections were a 0.25 m length of connecting flue pipe, the Recoheat Airflow Heat Recovery unit and 0.5 m length of connecting flue pipe. The connecting flue pipe components were painted with PlastiKote industrial high heat. The lower wall in Zone A was situated 450 mm from the connecting flue pipe components i.e., 3 times the diameter.

This was then connected to the twin wall flue using a transformation component 0.45 m below the ceiling in Zone A. The twin wall components were installed to form a chimney that extends to the extract hood in Zone C.

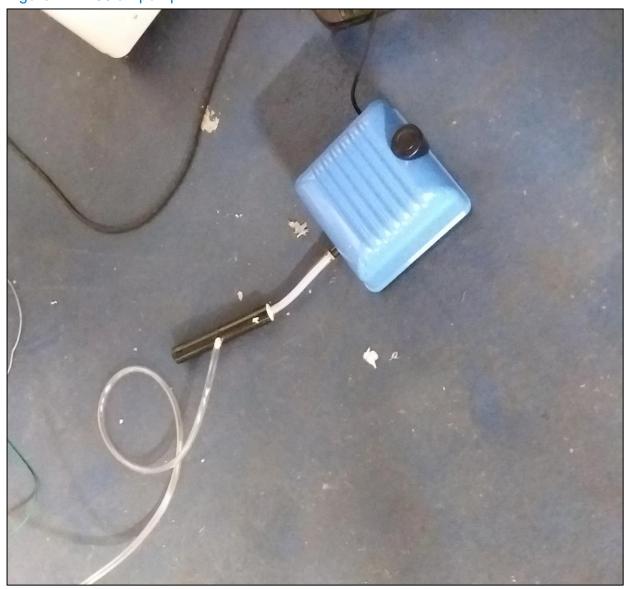
Figure 1 - V-60 air pump

During the initial thermal test, the pump was connected to the coil and was operational for the first 2 hours from start of test. Pump operation was then stopped for 10 minutes to assess the affect on the temperature of the hose and structure under these conditions.

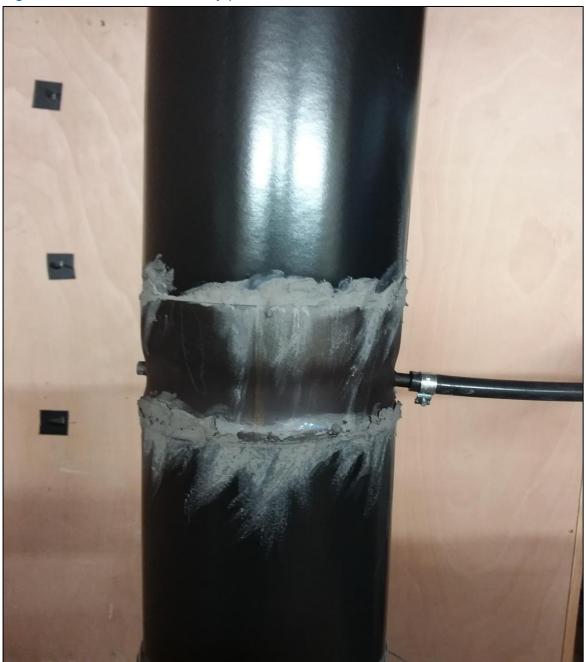
Figure 2 - Airflow heat recovery product

The Recoheat Airflow Heat Recovery unit was tested to a T450 and G rated designation using a custom-built structure to ensure the unit was safe to operate at the temperature and sootfire designation. This was tested using the BS EN 1856-1:2009 test configuration.

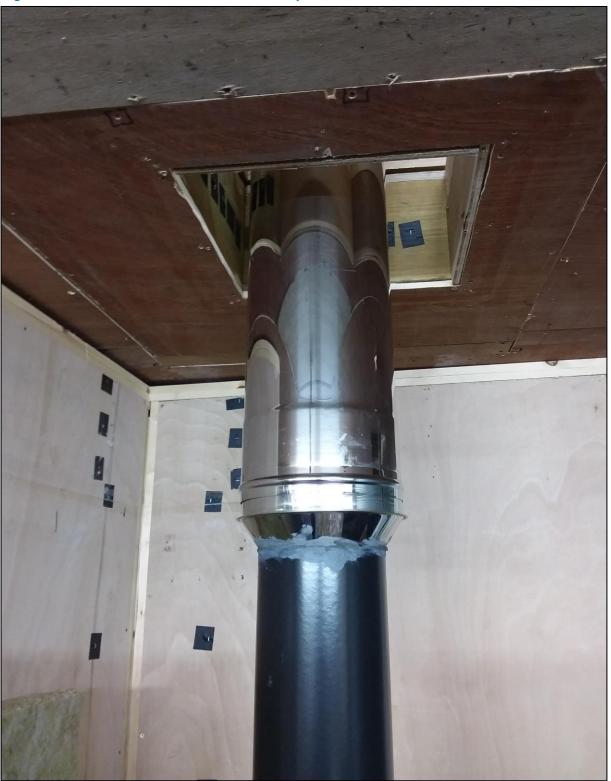
Figure 3 – Connection to twin wall chimney

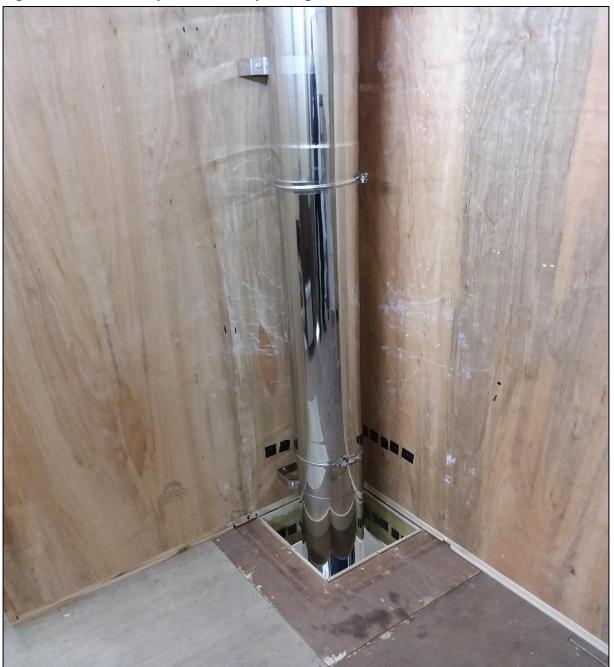
Figure 4 – Twin wall system chimney through Zone B
